**Assessing 'HydroFLOW' Technology and Side-Stream Filtration in High Silica Concentration
Groundwater for Prospective Operational Benefits**

Chemical Diagnostics and Engineering Group (C-CDE)

Los Alamos National Laboratory

Report Date: December 2015

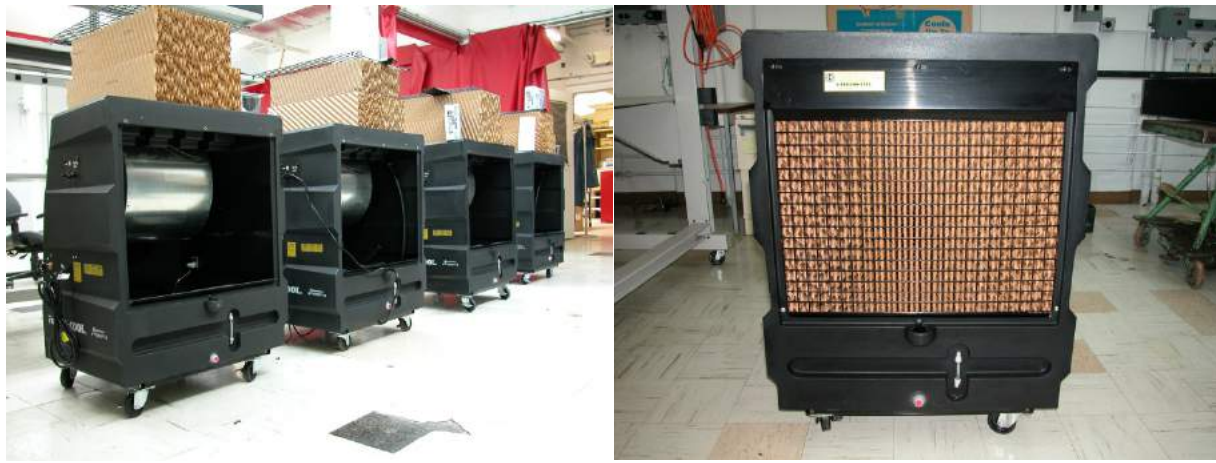
Figures 1&2. (1-Left) Four identical Port-A-Cool units for assessment. (2-Right) Port-A-Cool Cyclone 3200 (as received).

Four identical Port-A-Cool Cyclone 3200 Portable Evaporative Cooling Units (Figure1) were procured and slightly modified to the following configurations for the assessment:

A Beckett 250 GPH Submersible Fountain Pump was placed in the right front corner of the basin for recirculation of the basin water. The 150W Life Gard Adjustable Aquarium Heater was placed in the manual fill opening in the center of the basin, just above the red drain plug seen in Figures 2 & 3.

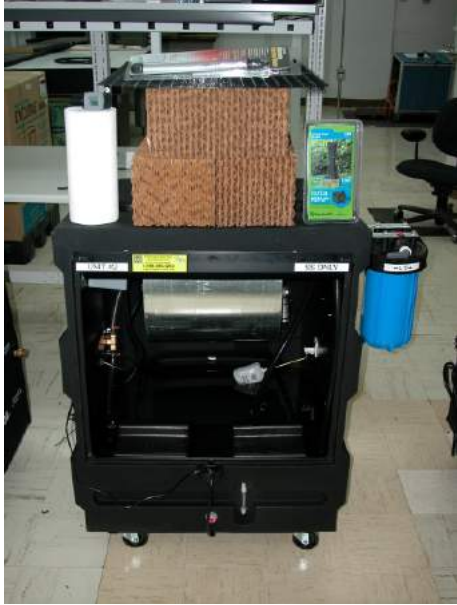
Figure 3. Unit #2 with Side-Stream Filtering Apparatus (50 micron filter)

In addition to the submersible pump and the heater placed in the control unit, a side-stream filtering unit was mounted to the upper right side of the Port-A-Cool unit as seen in Figure 3. The Beckett submersible pump was then connected to the side stream filter in this apparatus for testing.

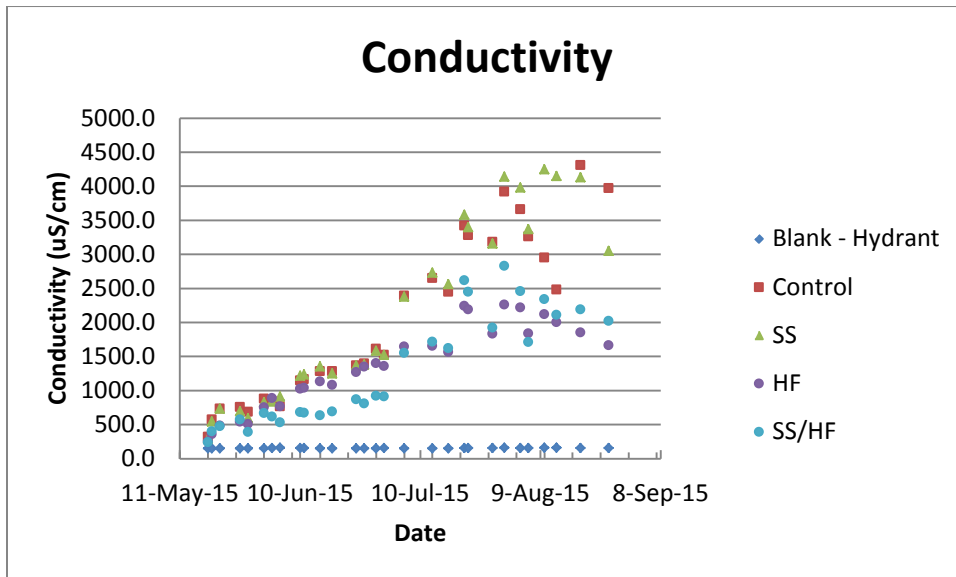
Figure 4. Conductivity Readings (Corning Checkmate II Conductivity Probe)

Figure 4, provides the daily conductivity readings that were taken throughout the testing period. It is evident that the “make-up” (Blank-Hydrant) water remains consistent throughout the fourteen weeks. Conductivity results for Units 1, 2, 3, and 4 (control, SS, HF, SS/HF) remain consistent during the first 3 weeks of testing. At approximately 1 month of testing, the SS/HF unit begins to separate from the group with slightly lower conductivities for approximately a three week period. At this time both the HF and SS/HF units show similar stable performance, while the control and SS units continue to show increases in conductivity over the final six weeks of testing. Data in early to mid-August indicates a reduction in conductivity for the control, however, a similar trend is observed for the SS only unit later in August, nearing the conclusion of testing and earlier for HF and SS/HF units, although not as extreme, from late mid-July through early August.

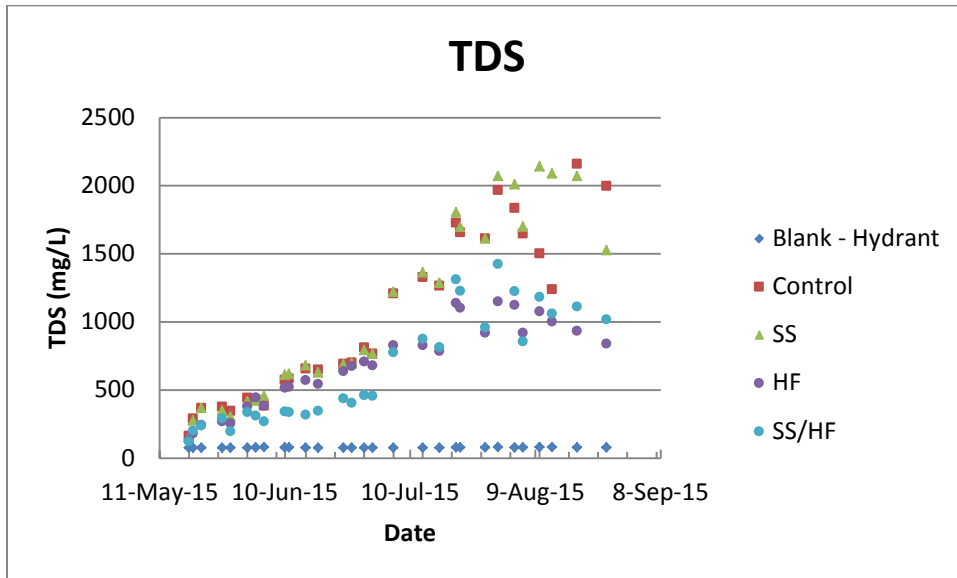
Figure 5. TDS Readings (Corning Checkmate II Conductivity Probe)

Figure 5 shows the daily trending of TDS for the four systems being assessed. The trends for both the conductivity and the TDS are the same as the probe measurement for TDS uses the Electrical Conductivity multiplied by a constant (which compensates for different metals, minerals and salts) to estimate TDS. For this specific probe the constant used was ~ 0.51 which is typical for KCl or NaCl, which might not always be representative of the chemistry of the water.

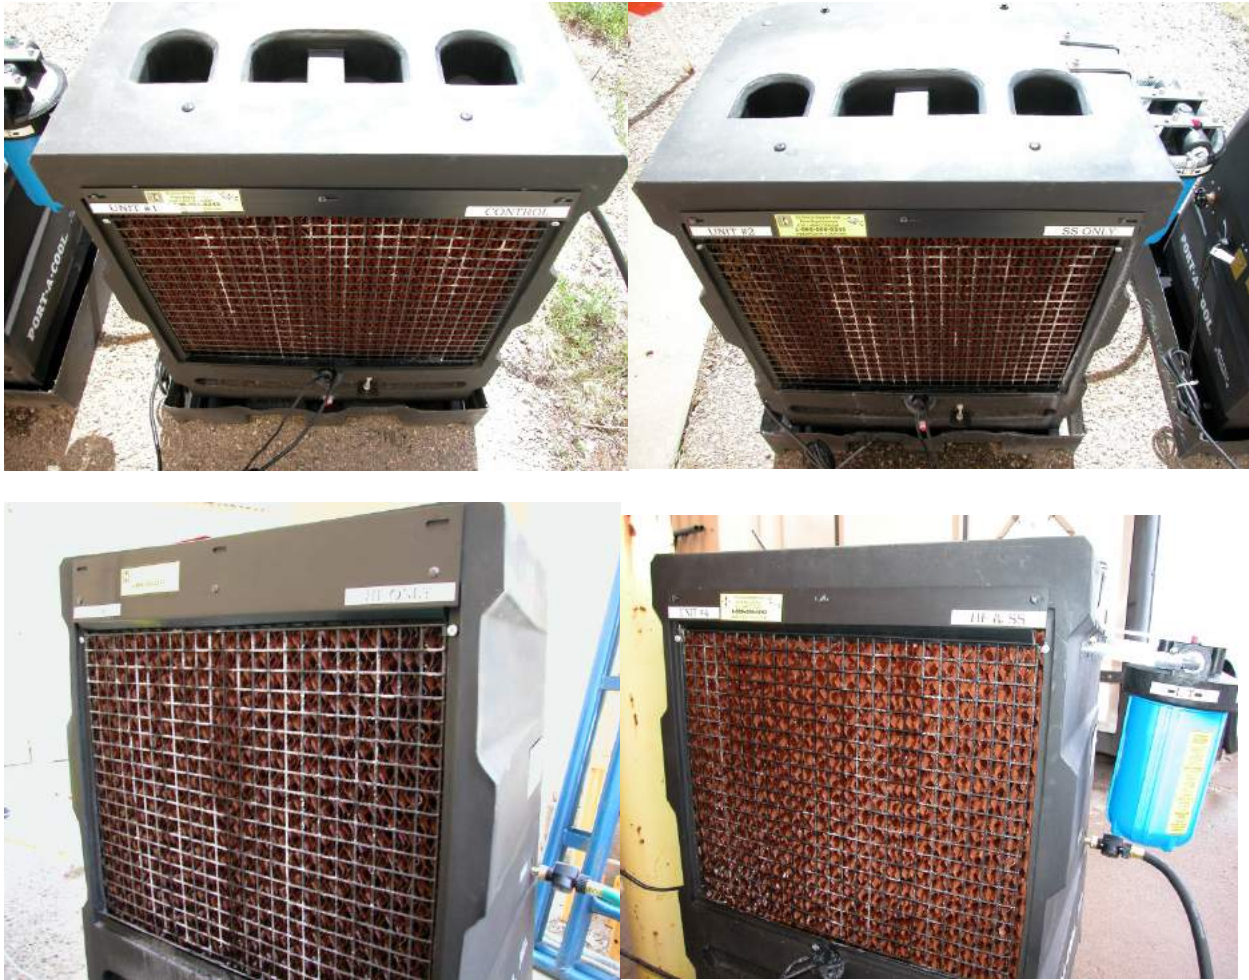
Figure 6. Scale build up on each unit being tested on May 26th and 27th. (top left) Unit #1 control, (top right) Unit #2 side-stream filtration only, (bottom left) Unit #3 HydroFLOW only, and (bottom right) Unit #4 side-stream and HydroFLOW.

Within the first week of testing (late May 2015), scaling was visible on the exterior pad screen and pads on all four units, as shown in Figure 6. Visual observations in early June indicated that the control and side stream units seemed to have less scale build up than the two units with the HydroFLOW transponder. The SS/HF combination was observed to have slightly less scale build up than that of the HF system. Both systems (HF, HF/SS) had milky recirculating basin water unlike the control and side stream units. However, visual observations later in June revealed similar milky recirculating basin water on the control and side stream units. On this date it was estimated that the systems were consuming approximately 18-25 gallons of water per day.

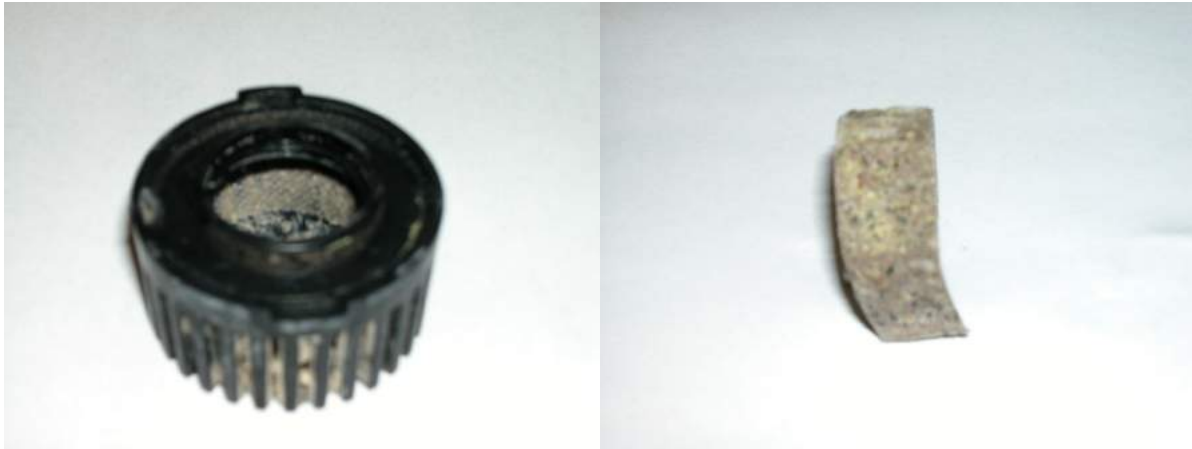
Figure 7. Debris and scale build-up on Unit #1 (control) pump filter July 22nd pre-cleaning.

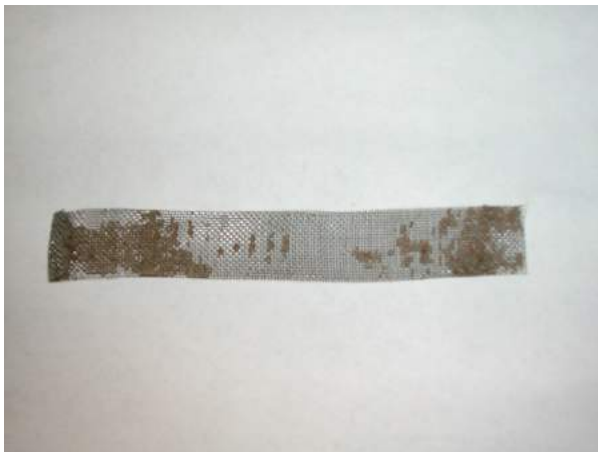
Figure 8. Scale build-up on pump filter to Unit #1 (post cleaning).

HydroFLOW transponders were providing a signal at all times, a wire was placed through the transponder and the ends were placed on the exterior of the testing apparatus. NWI provided an oscilloscope at this time to perform daily checks of the transponders. At this time, the SS/HF unit was observed to have a significantly reduced flow through the side stream filter. By the end of June, the flow was significantly reduced and had no flow by July 6th. A second round of dip slides were taken on June 29th and provided to NWI. By July 22nd the control (Unit# 1) had major scale build up on the main pump, as shown in Figure 7. The pump was removed and the filter was cleaned and replaced as shown in Figure 8.

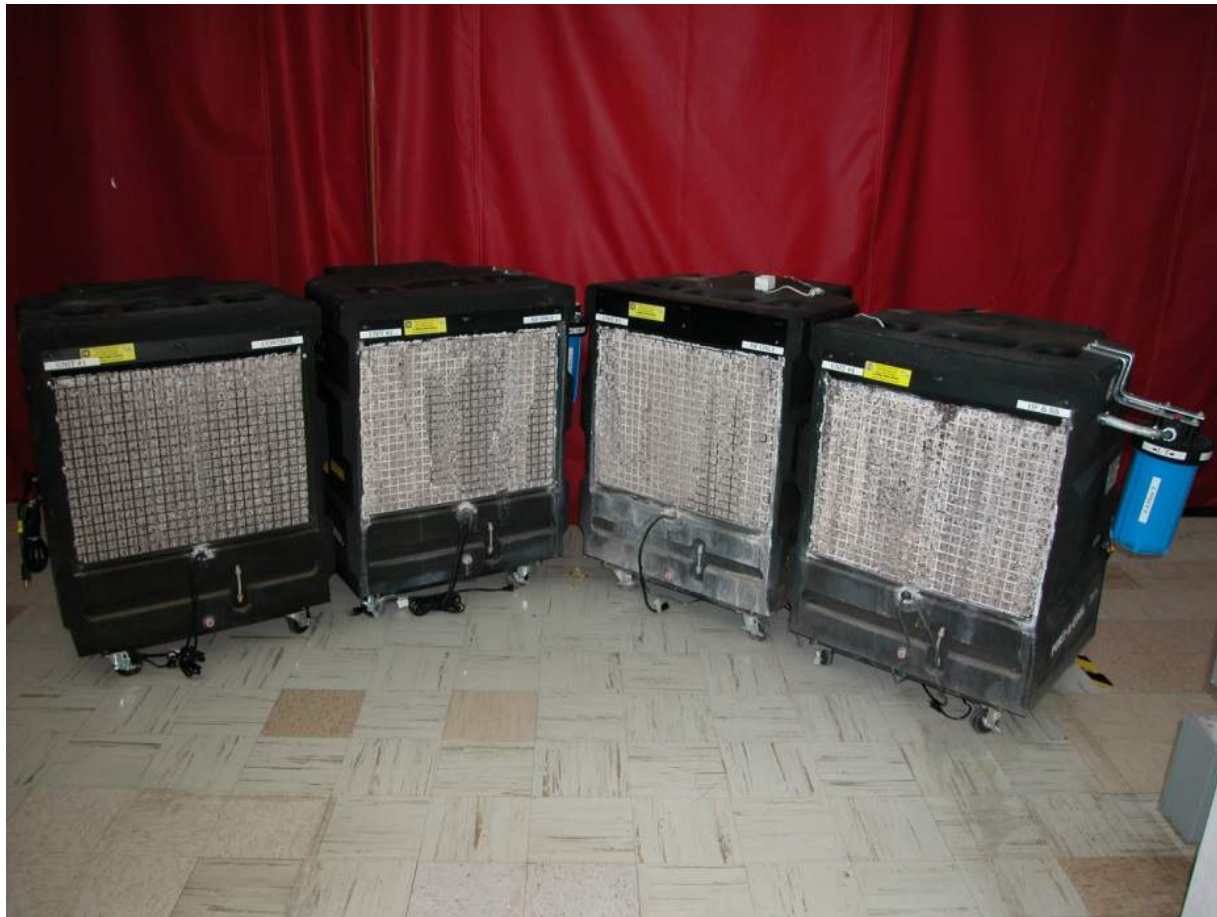
Figure 9. Post-test condition of evaporative coolers (L-R: Control, SS, HF, SS/HF).

Figure 9 shows the condition of the four units tested during this assessment. From a visual perspective, the HF only unit (second from the right) had the least appealing result followed by the combination SS/HF, the SS only, and the control. Upon closer inspection, it was evident that the side stream only (Unit #2) produced a 'flakey' build up shown in Figure 10, unlike the sandy sediment that was observed in the other three units. SEM imaging was performed on both interior and exterior scale specimens of which will be discussed later in this report. Additional images of the equipment (post-test) can be viewed in Appendix B at the end of this report.

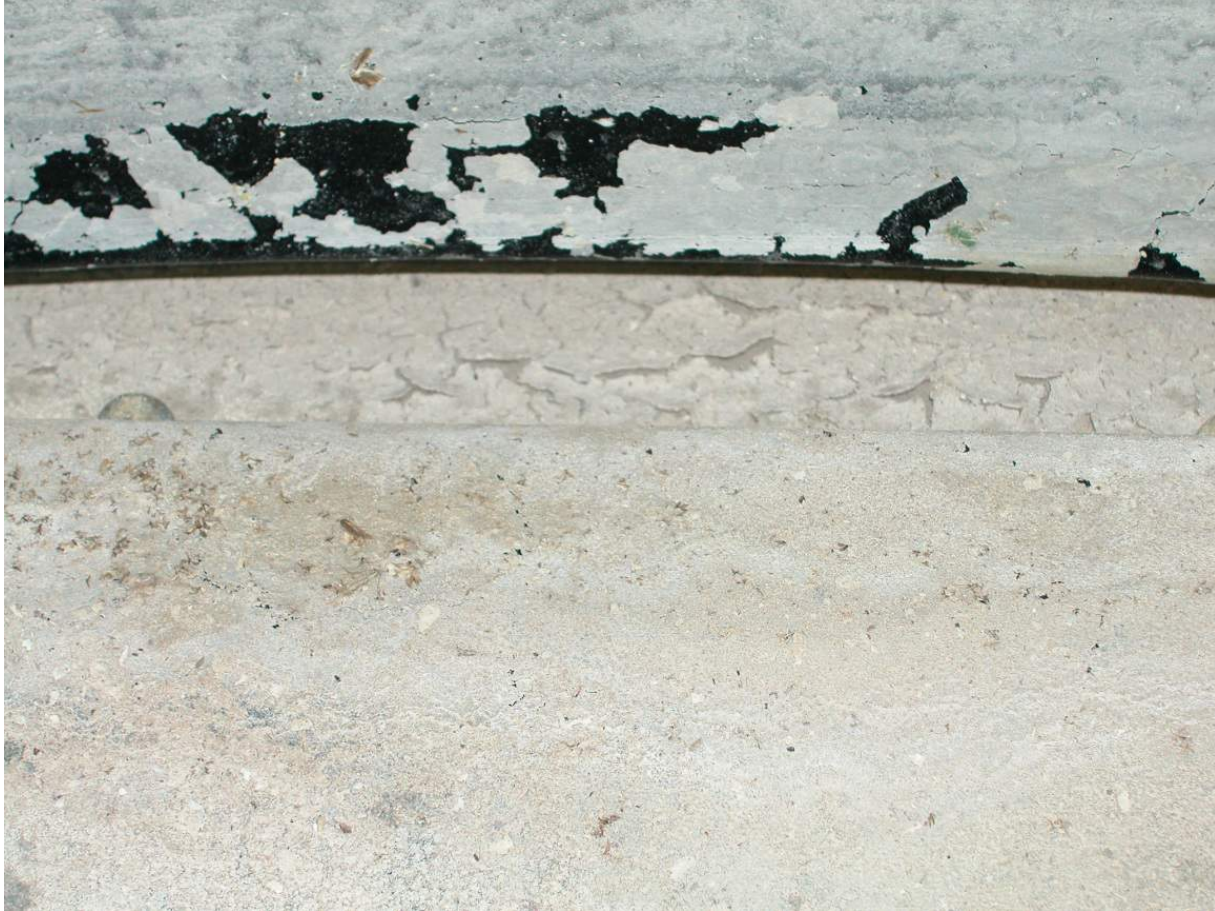
Figure 10. Close up image of scale flaking in Unit #2 basin (Side Stream Filter Only)

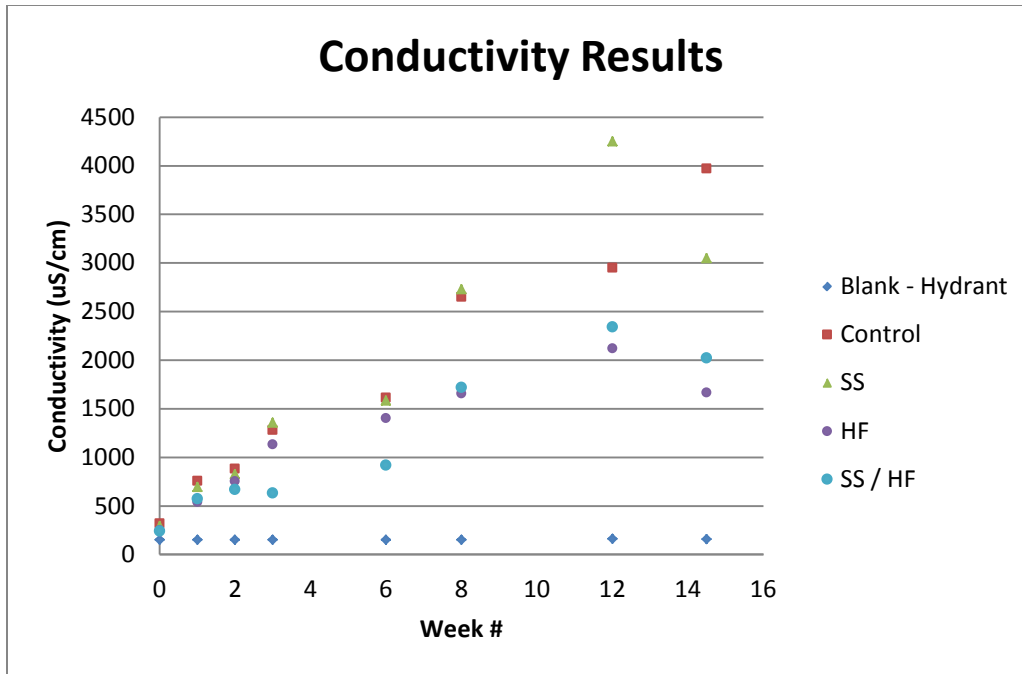
Figure 11. Conductivity Results

Conductivity results shown in Figure 11, and listed in Table 3, indicate trends similar to TDS. Make-up water provided by Los Alamos County (LAC) was fairly consistent in the range of 150 uS/cm. While the control unit showed a constant increase in conductivity with time, the three remaining units showed a maximum conductivity value being reached at twelve weeks. The SS only unit shows a more pronounced trend in comparison to the HF only and SS/HF combination as it reached a value of 4250 uS/cm. At the conclusion of testing, in comparison to the control, the side stream filtering system had conductivity values reduced by 25%, the HF only system by ~58%, and the SS/HF combination by 50%.

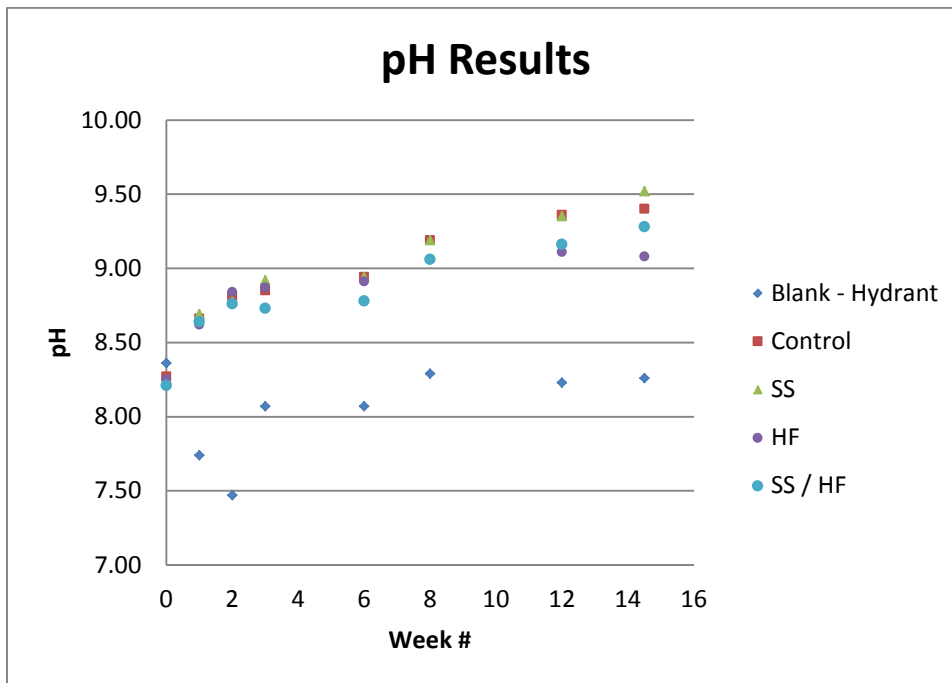
Figure 12. pH Results of evaporative cooler basin water.

pH was tracked for the duration of the test and plotted in Figure 12. All samples taken from the coolers show a slight increase over time. Values ranged from 7.47 to 8.36 for clean make-up water, and 8.21 to 9.52 for process waters. As time progressed in testing, the gap in pH gradually widens starting between 6 and 8 weeks. At the conclusion of testing, the gap between the SS only and the HF only ranged from 9.52 to 9.28, with the pH of the HydroFLOW unit being the lowest of all the systems tested. From a LANL perspective, NPDES discharge limits for major cooling towers in the general vicinity of TA-3, have a pH requirements for discharge to outfalls from 6.6-6.8, which is slightly more stringent than those outside of the tech area that can range from 6.0-9.0.

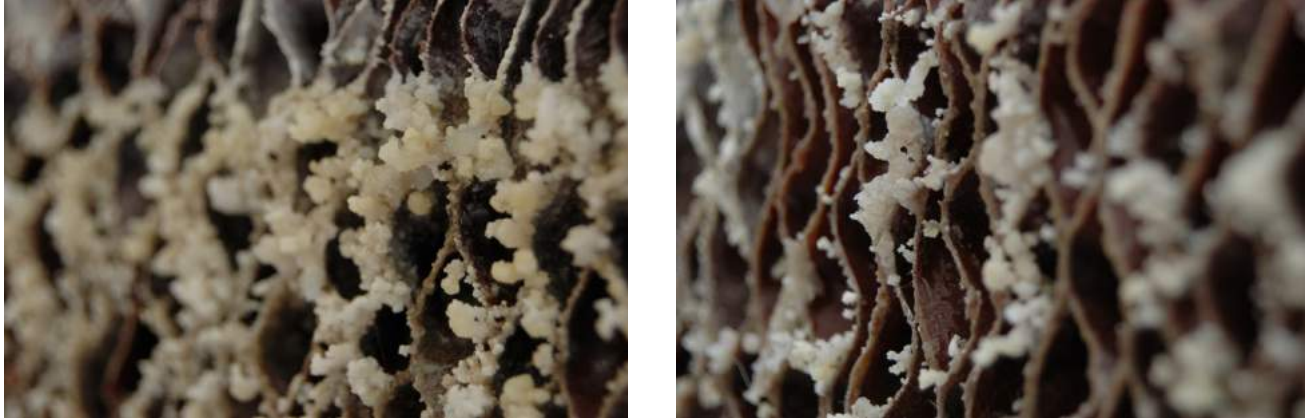
Figure 13 a and b. Post-test images of scale build up on the evaporative cooler pads. a) left - Side-stream filter only Unit #2 and b) right - Control Unit #1

Micrographs of scale build up were taken using a FEI Inspect F scanning electron microscope. Samples were taken from the surface of the evaporative cooler pads (Figure 13 a and b) of the unit in addition to the dried sediment within the basins of each unit as seen in Figure 14.

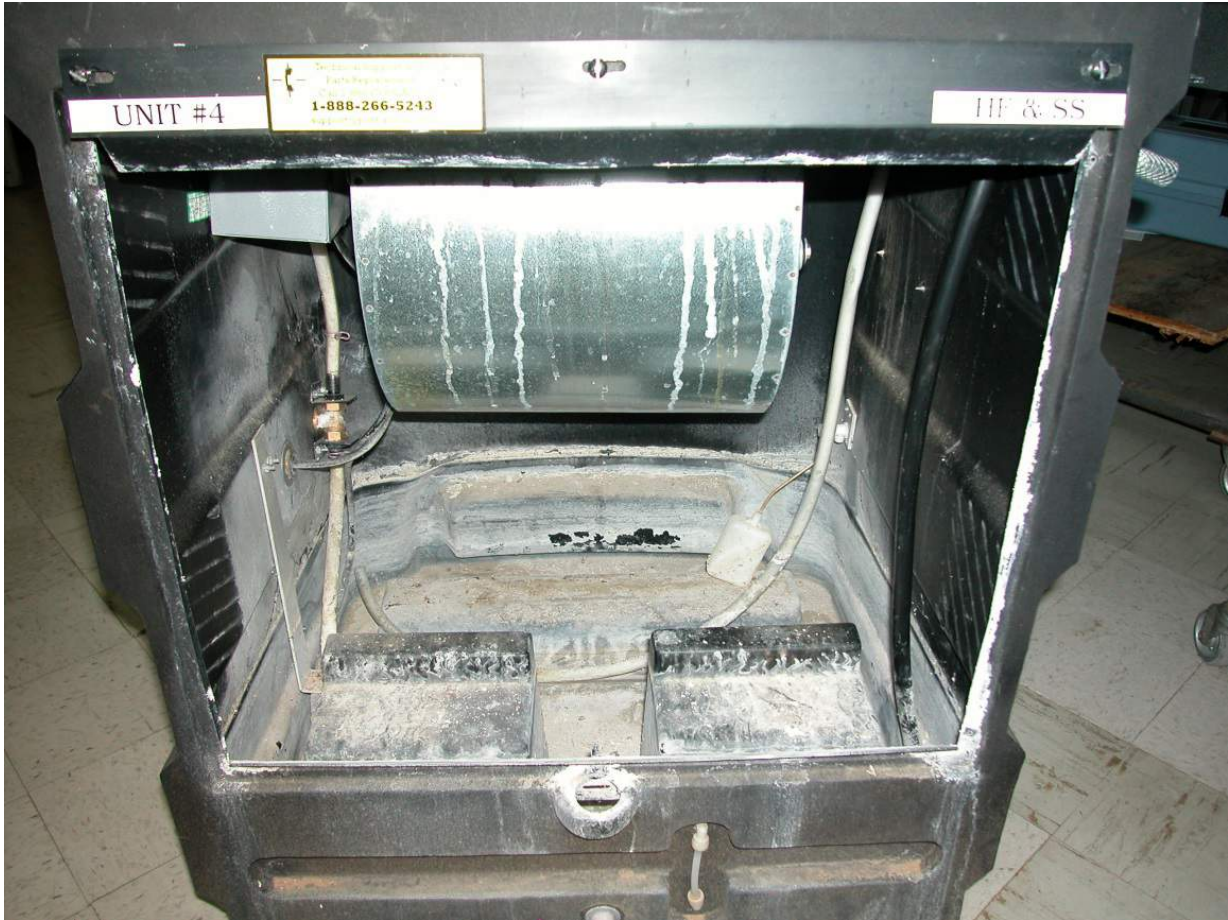
Figure 14. Post-test images of scale and sediment in Unit #4 (SS/HF)

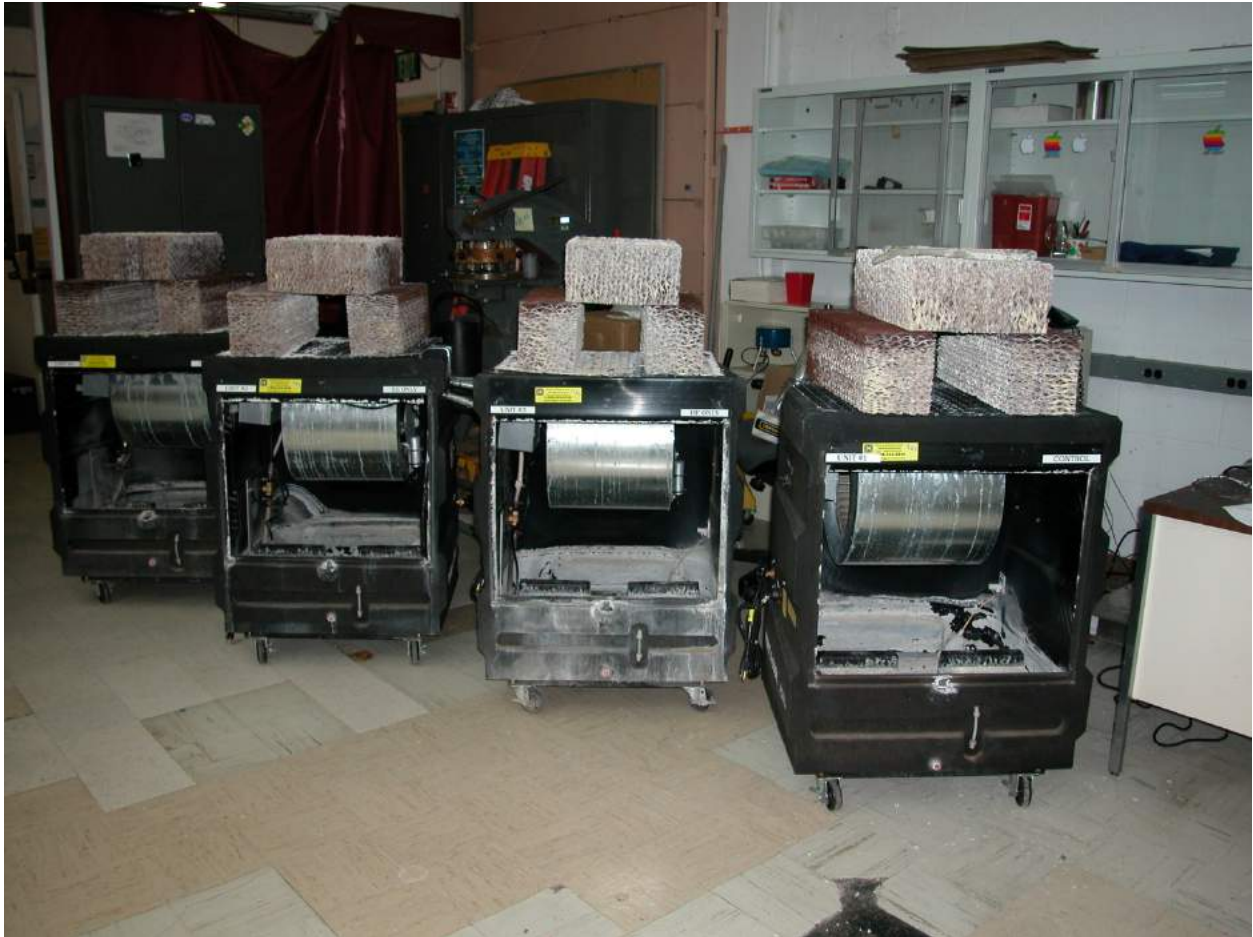
Post-test image of evaporative coolers (L-R: SS/HF, SS only, HF only, Control)

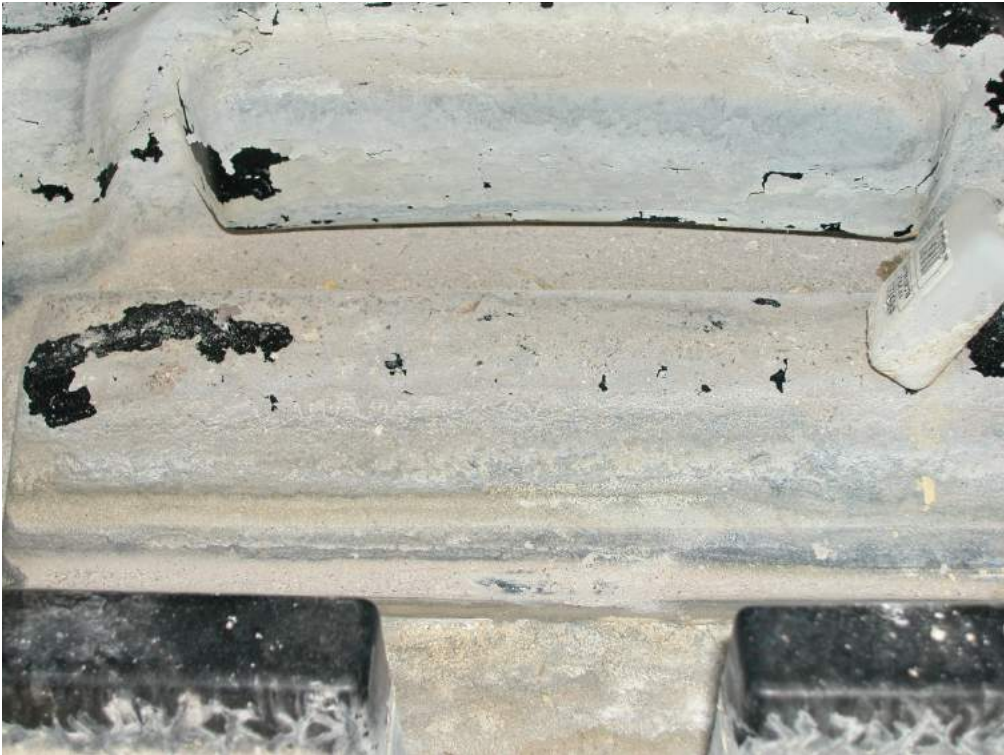
Post-test image of scale / sediment in Unit #1 basin

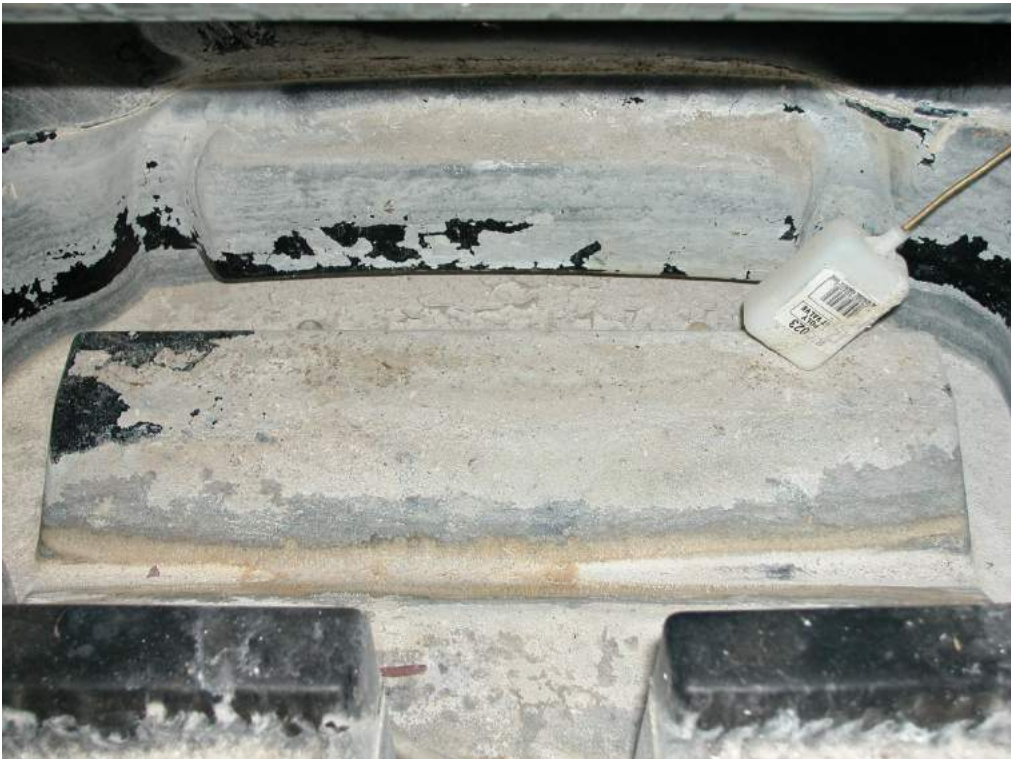
Post-test image of scale flaking in Unit #2 basin

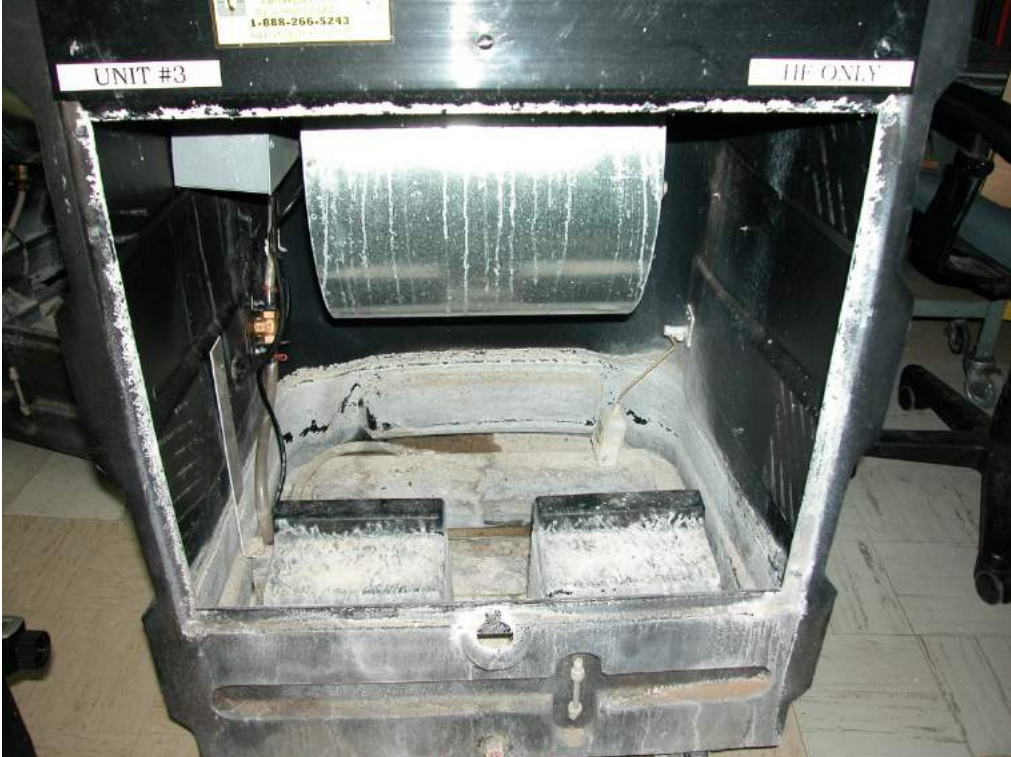
Post-test image of scale / sediment in Unit #3 basin

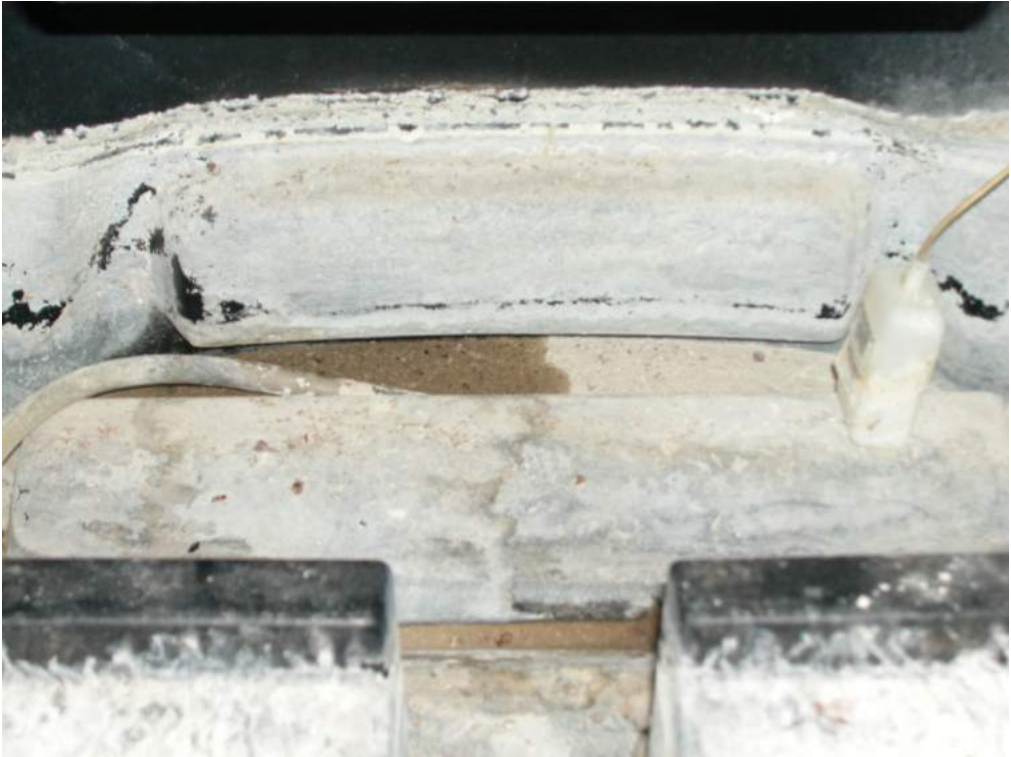
Post-test image of scale in Unit #3 basin

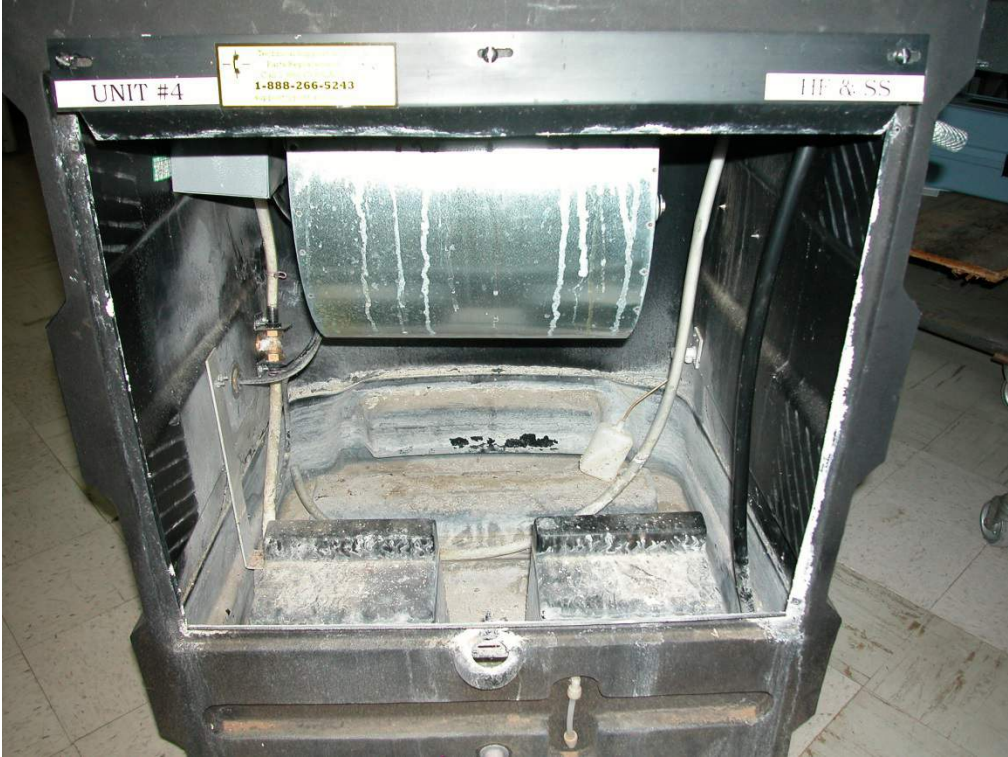
Post-test image of scale / sediment in Unit #4 basin

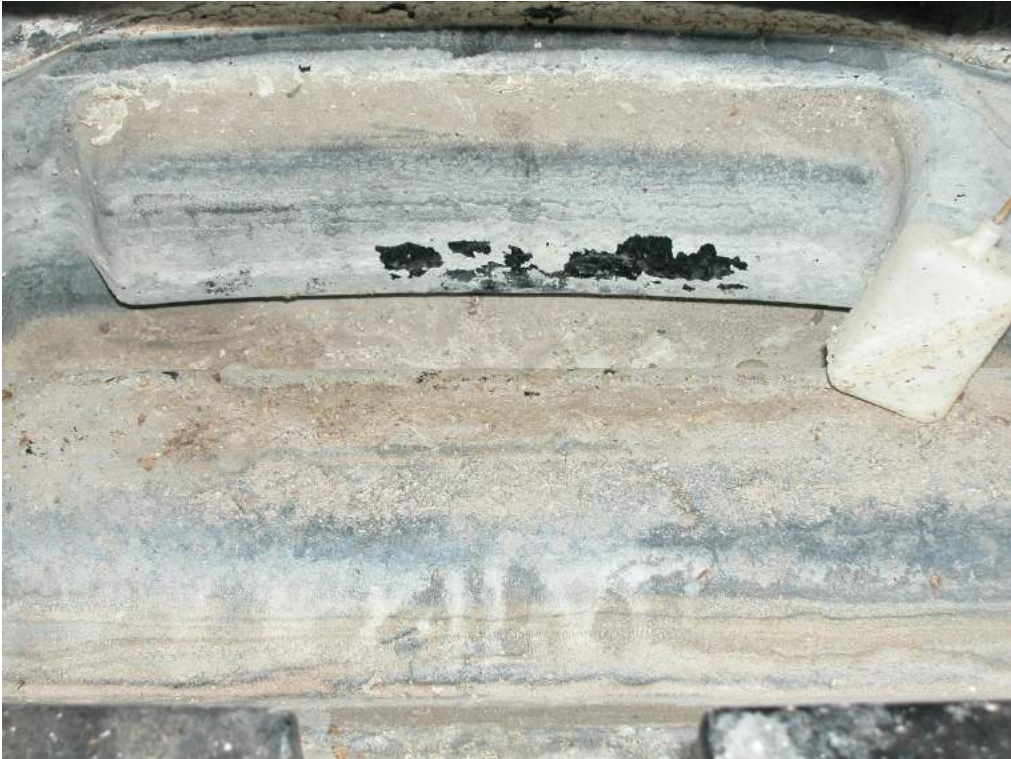
Post-test image of scale in Unit #4 basin

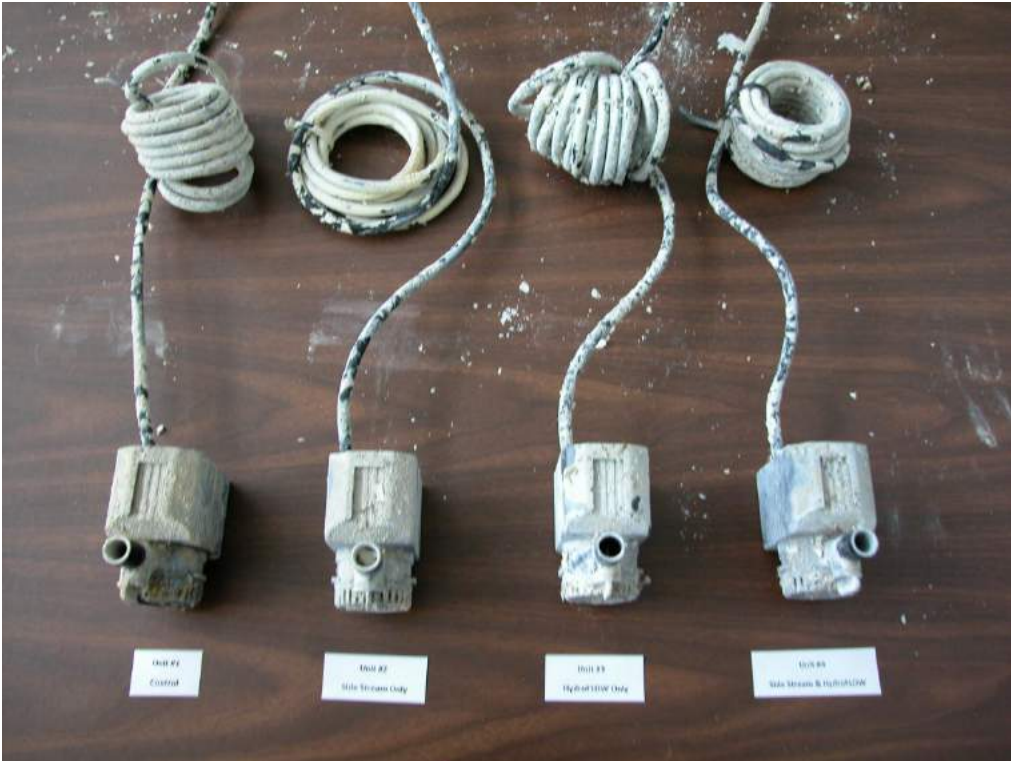
Post-test image of scale build up on recirculation pumps

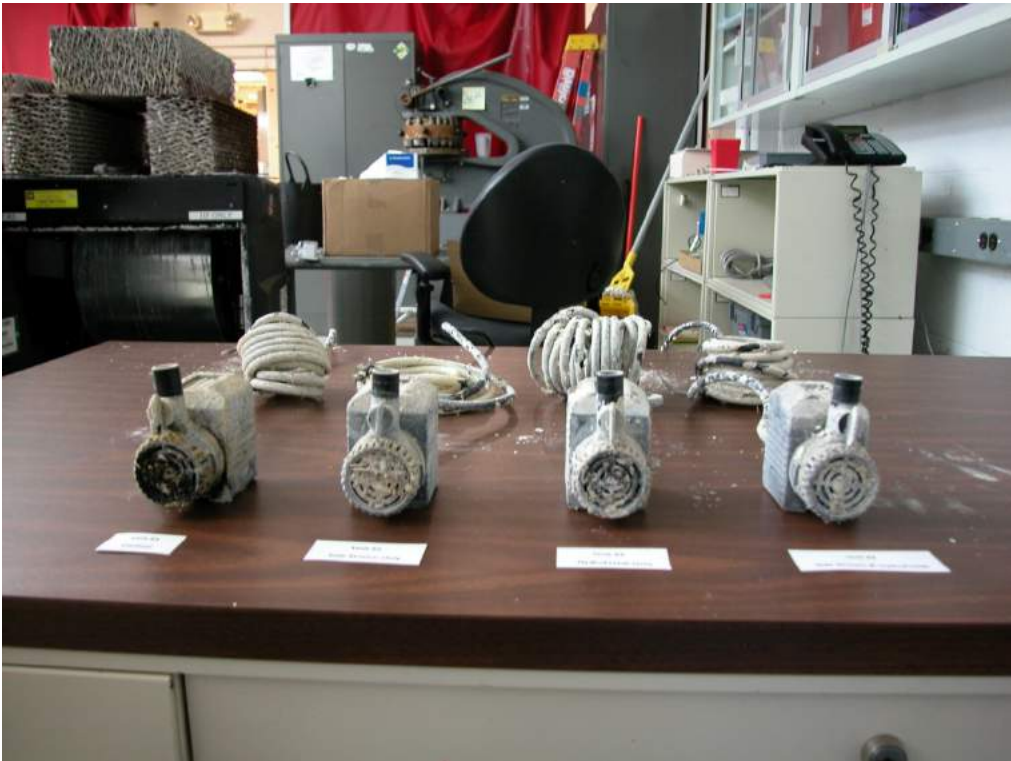
Post-test image of scale build up on recirculation pumps

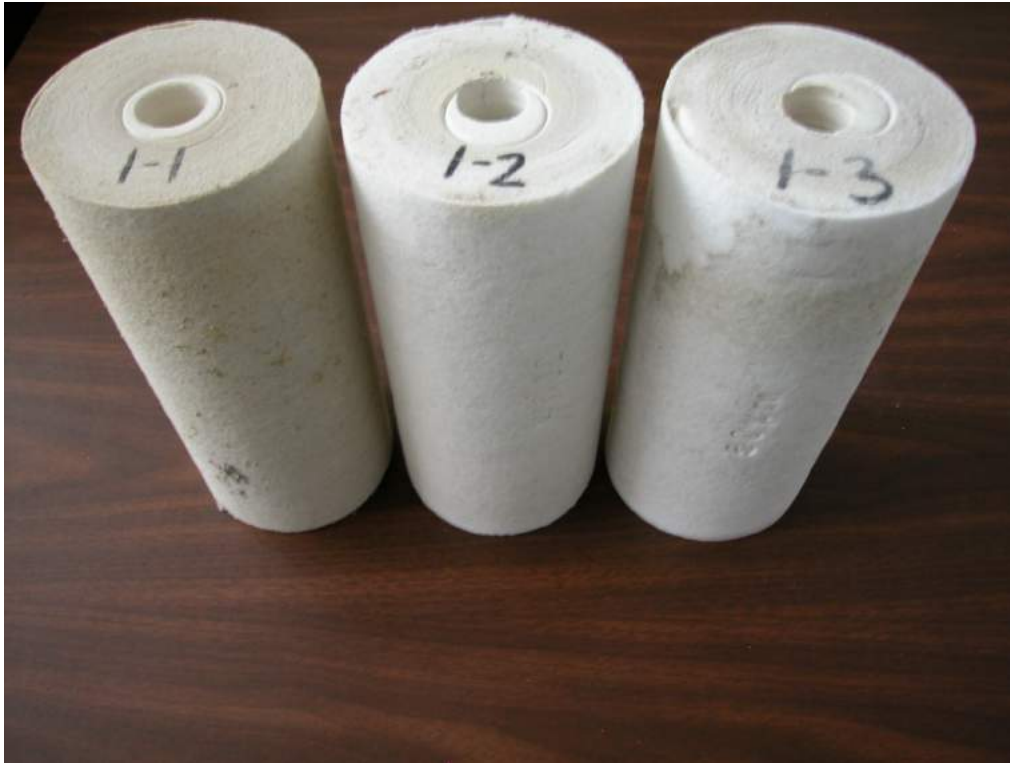
Post-test image of filters from Unit #2 (Side Stream Only)

Filters from the side-stream filtering apparatus's were removed and allowed to dry. Unit #2 had a total of 3 filters that were used that had mass increases of 30.6, 25.7, and 17.2 grams while Unit #4 had two filters that had mass increases of 45.1 and 37.5 grams. The combination of the side-stream filter with the HydroFLOW transponder was able to filter out 11% more solids with one less filter. Images of the dried filters can be viewed in Appendix B, Figures L-N.

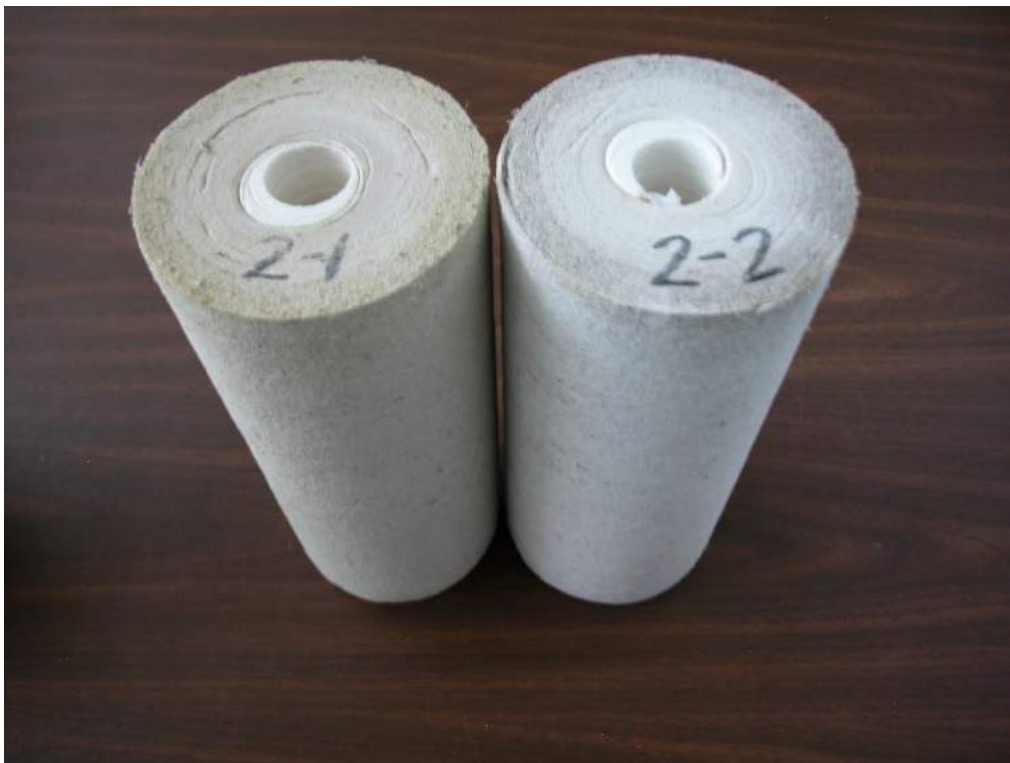
Post-test image of filters from Unit #4 (Side Stream w/ HydroFLOW)

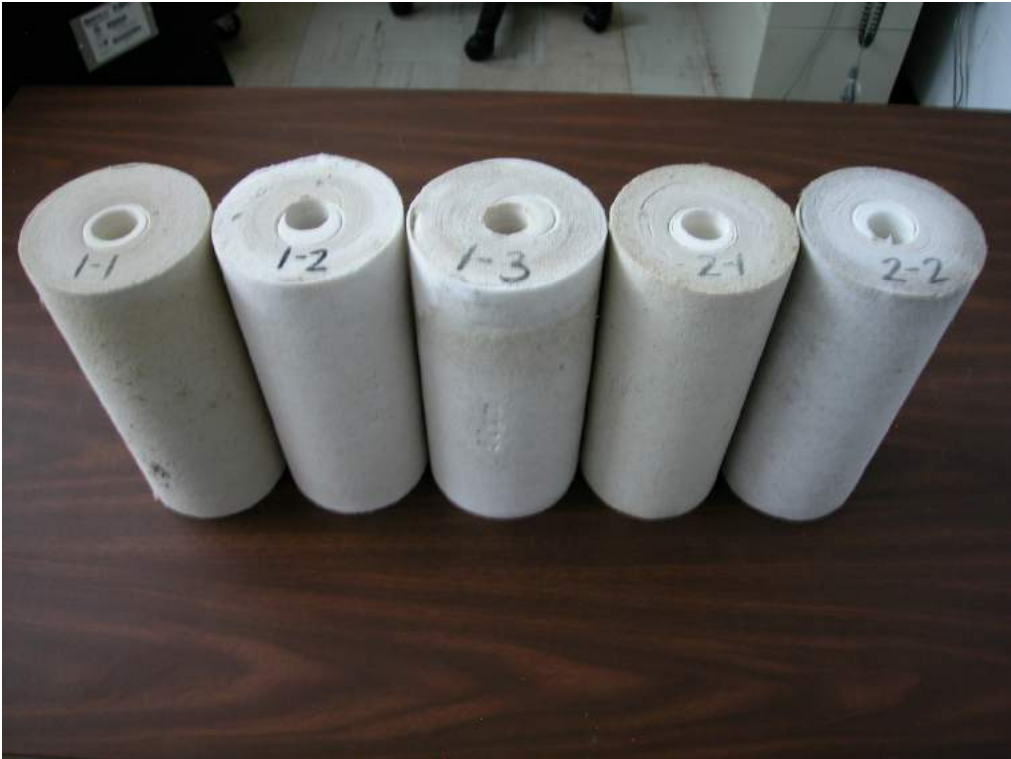
Side-by-side comparison of filters from Unit #2 and Unit #4

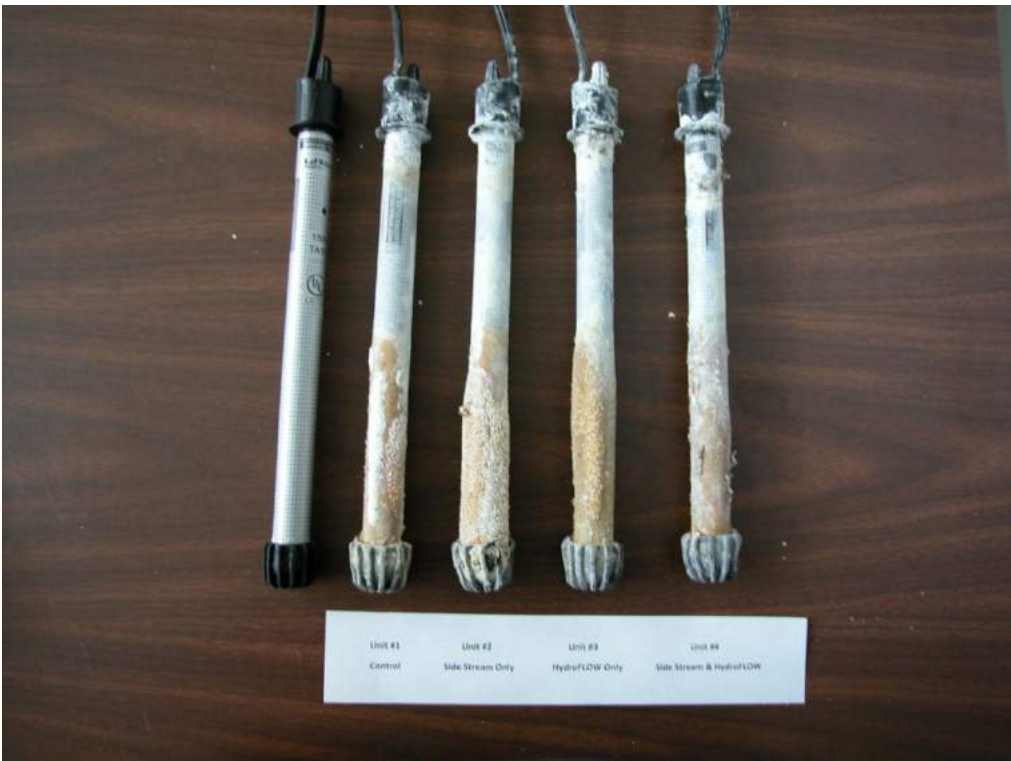
Side-by-side comparisons of scale build up on heaters (L-R: New, Control, SS, HF, and SS/HF)

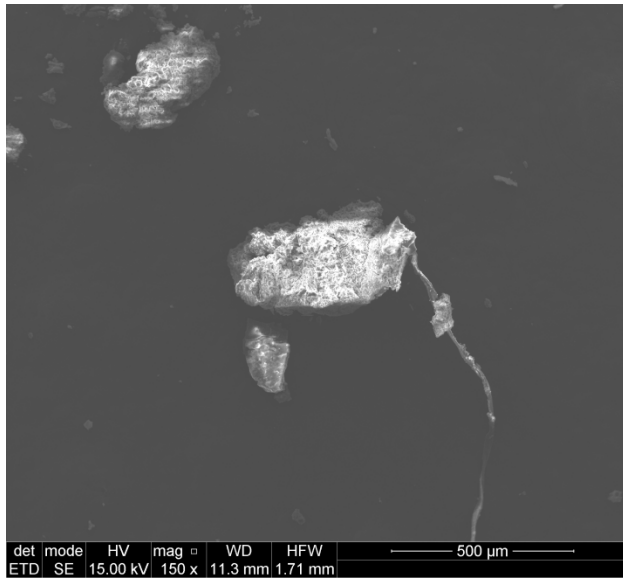
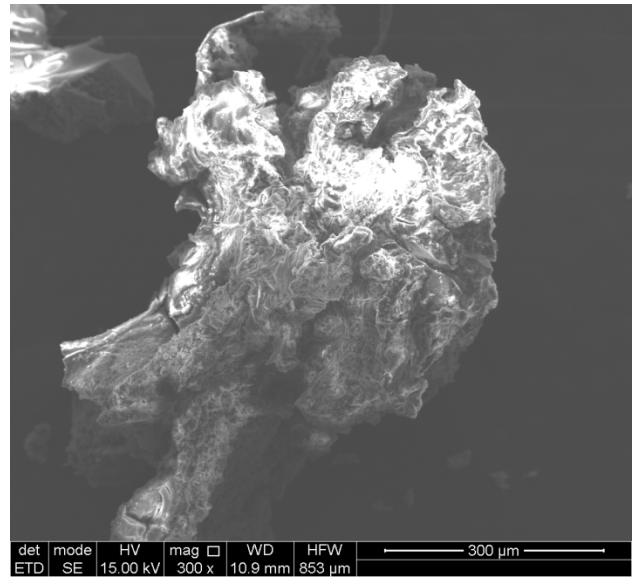
Scale build up taken from make-up water hydrant.
